# CASE STUDY

PROJECT  
Multi-disciplined Survey of London Dock

## MULTI-DISCIPLINED SURVEY OF A LONDON DOCK

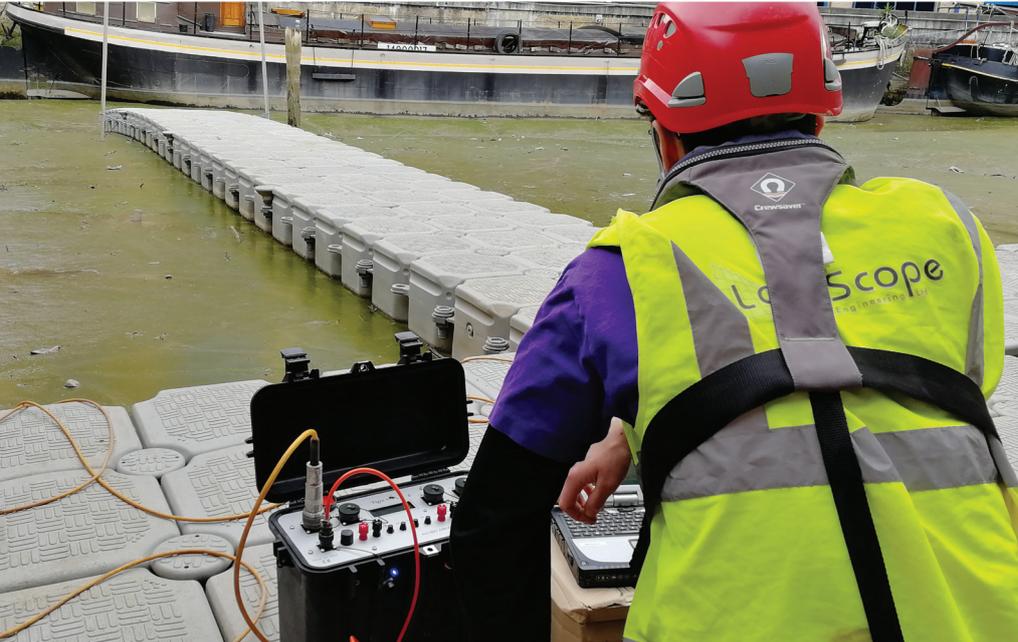
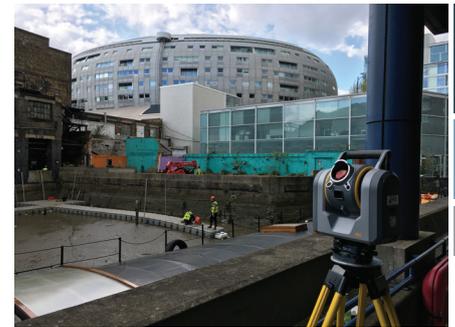
SX10 Laser Scan Data Capture, Dock-Side

The geophysical survey points were accurately surveyed using a Trimble SX10 Scanning Total Station on predefined control locations on the surrounds of the dock wall.

The SX10 was also used to collect high-resolution point cloud data and part of the photography for the wall position and condition reports. The SX10 photography was supplemented with additional high resolution SLR camera imagery.

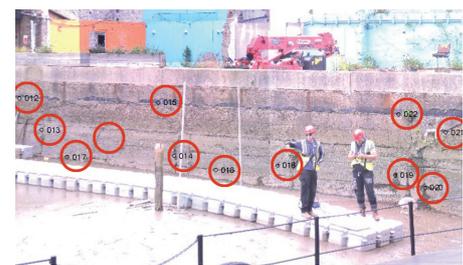
SX10 Laser Scan Data Combined with Colour Photography

The point cloud provided all of the level and positional data required. This data was extracted into an AutoCAD drawing in conjunction with the results of the geophysical survey. These results, along with the photography and derived condition report, were issued to the client. These deliverables fed directly into the client's design models and monitoring scheme.
