# CASE STUDY

PROJECT  
Structural GPR Survey (Void Mapping)

## STRUCTURAL GPR SURVEY (VOID MAPPING) - SERVICE RESERVOIR

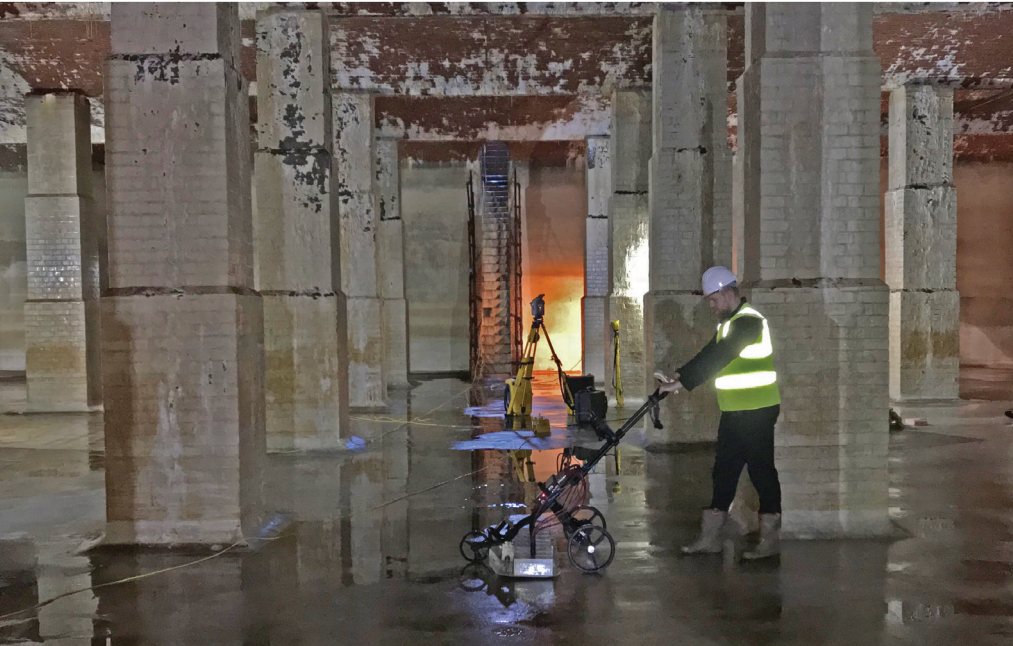
The laser scanning data was processed and a point cloud produced. This data was used to position the GPR data and allow for a topographic base map to be extracted to give context to the survey results. The point cloud data was also to be used to aid subsequent design and restoration planning.

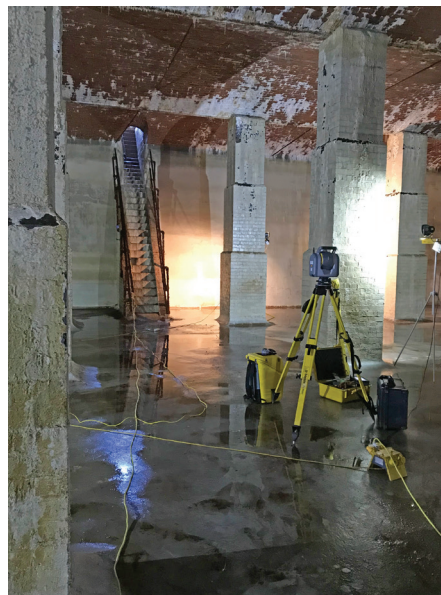
Figure 1: Trimble SX10 Laser Scanning of Reservoir

The site works were completed within one shift and included GPR data collection and laser scanning of the internal chamber.

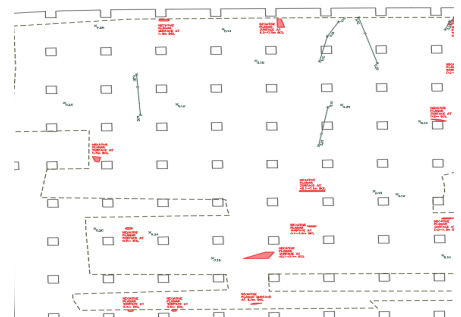
Figure 5: Interpretive AutoCAD Drawing Detailing Locations of Potential Void Features / Water Pathways

The GPR data was filtered and post processed by LandScope's team of geophysicists. The GPR data interpretation was added to the base map produced from the laser scanning survey. The GPR successfully located a number of substantial void features within the reservoir floor slab (Figure 5 below).
