# CASE STUDY - RIDDERHAVEN, NETHERLANDS

MURPHY YOUNG GROUP, 2018

## PROJECT SUMMARY

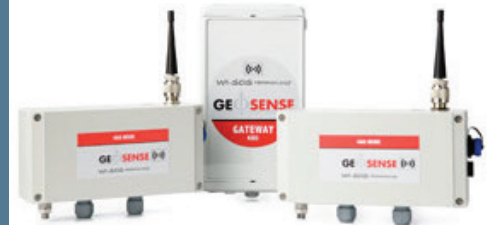
Geosense WI-SOS 480 central gateway interfaced with Trimble 4D Control.

Twenty-four tilt meters were installed on a total of eighteen columns. Eight critical boundary columns had both a high and low-level tilt meter installed on the same face, allowing for IPI chain analysis to be performed.

Daily sensor analysis and alarming reports were automatically distributed via email to all stakeholders directly from Trimble 4D. Interpretation of the data indicated that the columns were displacing due to temperature variations within the structure, allowing the OIP to expand and fill any cavities. The resultant effective on the columns showed a net growth displacement in an easterly direction of the structure.
